DEPARTMENT OF TRANSPORTATION

Quality Assurance and Source Inspection

OBG CROSS BEAM CB1

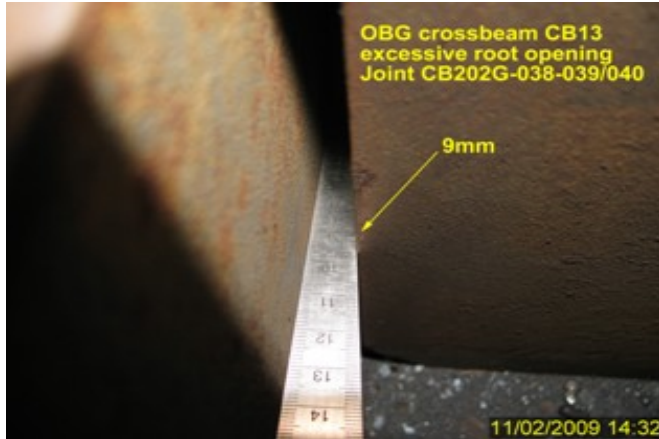
This QA observed that ZPMC appears to be nearly complete with the fit up of this crossbeam. This QA performed random visual inspection of the weld joint fit up on this crossbeam and discovered numerous noncompliant fillet weld joint root openings. The root openings range in size from 6mm to 9mm. The maximum allowed per the contract documents is 5mm. The weld joints and root openings are as follows:
